# Wheatcroft v. City of Glendale, et al No. 2:18-cv-02347-MTL

Wheatcroft, et al v. City of Glendale, et al, NO. 2:18-cv-02347-MTL

# Wheatcroft, et al v. City of Glendale, et al

November 6, 2020

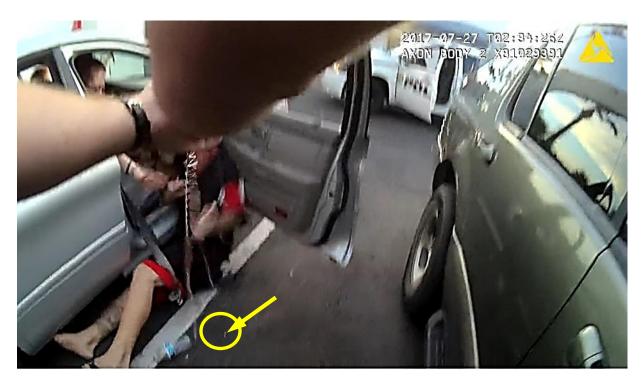
evidence, the body cam video clearly shows that one of the probes deployed by Officer Schneider missed Mr. Wheatcroft and landed on the ground near him (Figure 30). Therefore, probe 1A was likely the probe that detached from Mr. Wheatcroft, and as a result was not part of any electrical circuits initially. Conversely, probe 2A likely struck Mr. Wheatcroft or was in sufficient proximity to his body, and therefore participated in subsequent drive stuns administered by Officer Schneider which resulted in greater area of arcing damage as compared to probe 1A. The evidence also indicates that probe 1A ultimately connected with Mr. Wheatcroft's body, which likely occurred during the struggle while Mr. Wheatcroft was rolling on the ground. Once probe 1A was attached or in sufficient proximity to Mr. Wheatcroft's body it became a part of subsequent drive stun applications.

Figure 30. Probe resting on the ground near Mr. Wheatcroft (screenshot from Officer Schneider's body cam video.

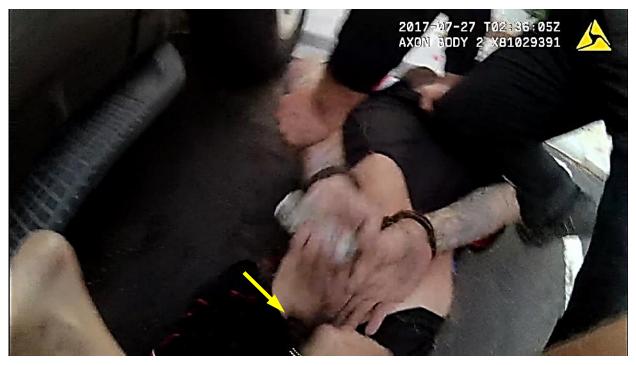
The last sequence administered by Officer Schneider was sequence 11, which lasted 4 seconds per the log report. Based on the video footage, sequence 11 was administered to the lower left buttock area on Mr. Whitecroft's body. The yellow arrow in Figure 33 indicates the position of Officer Schneider's X2 ECD while he was administering sequence 11 drive stun.

Figure 33. Location of the sequence 11 drive stun application by Officer Schneider.
